UNITED STATES
DEPARTMENT OF LABOR
MINE SAFETY AND HEALTH ADMINISTRATION
METAL AND NONMETAL MINE SAFETY AND HEALTH
REPORT OF INVESTIGATION

Fatal Machinery Accident
November 6, 2005

Empire Mine
Empire Iron Mining Partnership
Palmer, Marquette County, Michigan
Mine I.D. No. 20-01012

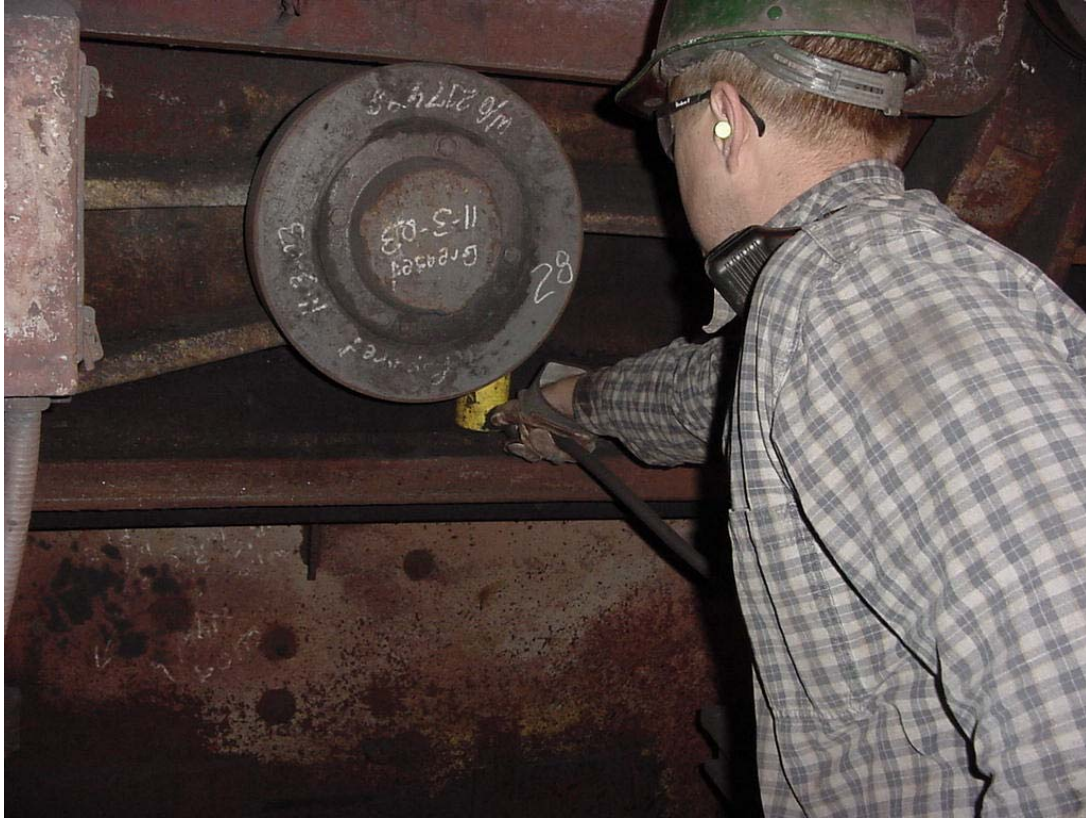
Picture #1

The moving floor frame of the enclosed area had 30 segments, referred to as pallets, attached to it. Each end of a pallet shaft was connected to the floor frame by rotational connections. This arrangement allowed the pallets to rotate around their shafts and dump their loads. Pallets were kept level in the cooler by the dump arm attached to the end of the pallet shaft outside of the enclosure in the cooler's inner diameter. The opposite end of the dump arms had a wheel (picture #1). The wheel would ride on a guide rail which governed the pallet position.

A common procedure to free a stuck pallet was to use a port-a-power and apply force. The port-a-power's cylinder was placed under the wheel end of the dump arm wherever the jack head would fit and the cylinder was extended until the pallet was free (see picture #1). The job was typically performed by two people. One person positioned the cylinder below and to the right of the wheel (see picture #1) and the second person operating the port-a-power would stand to the right of the person setting the cylinder in place. As the port-a-power was positioned, the operator pressurized the cylinder enough to keep it in place. The person handling the port-a-power then moved away and the cylinder was raised until the pallet was freed. The amount of force needed to free a stuck pallet varied.

Demonstration of placing port-a-power cylinder under a stuck cooler pallet dump arm.

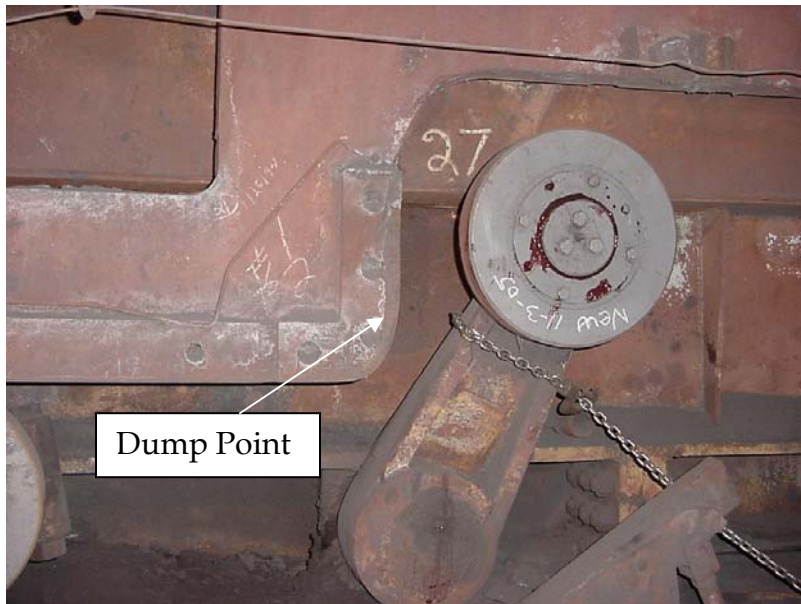
Picture #2

provided with a guard (attached sketch – Appendix C). The pallet shaft was eccentric with over 60 percent of the pallet and load weight to one side of the shaft. This arrangement caused the pallet to tip by gravity at the dump point under normal conditions (see picture #2). The speed of the floor was variable and was set depending on the characteristics of the pellets. At the time of the accident, the cooler reportedly completed one revolution in approximately 45 minutes.

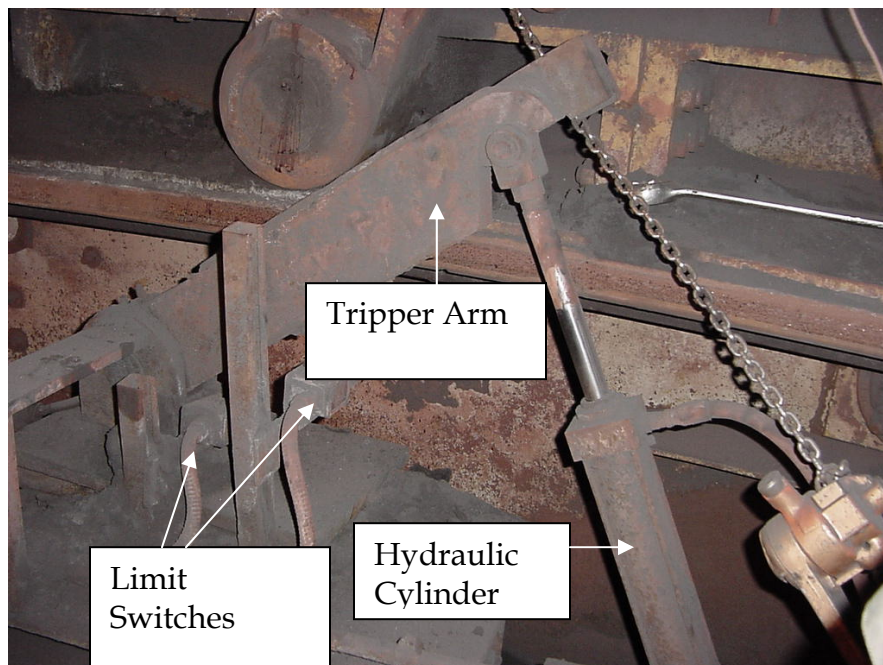
Picture #3

The cooler pallet tripper arm, or pallet trip, was referred to as the “sure dump”. This device activated when a pallet failed to dump. When this occurred, the wheel stayed down and rolled onto the cooler pallet tripper arm. This compressed a hydraulic cylinder, applying additional rotational force to dump the pallet. If the additional force didn’t activate the pallet to dump, the cooler continued to travel and the hydraulic cylinder collapsed until the tripper arm contacted the stuck pallet warning and stop limit switches (see picture #3).

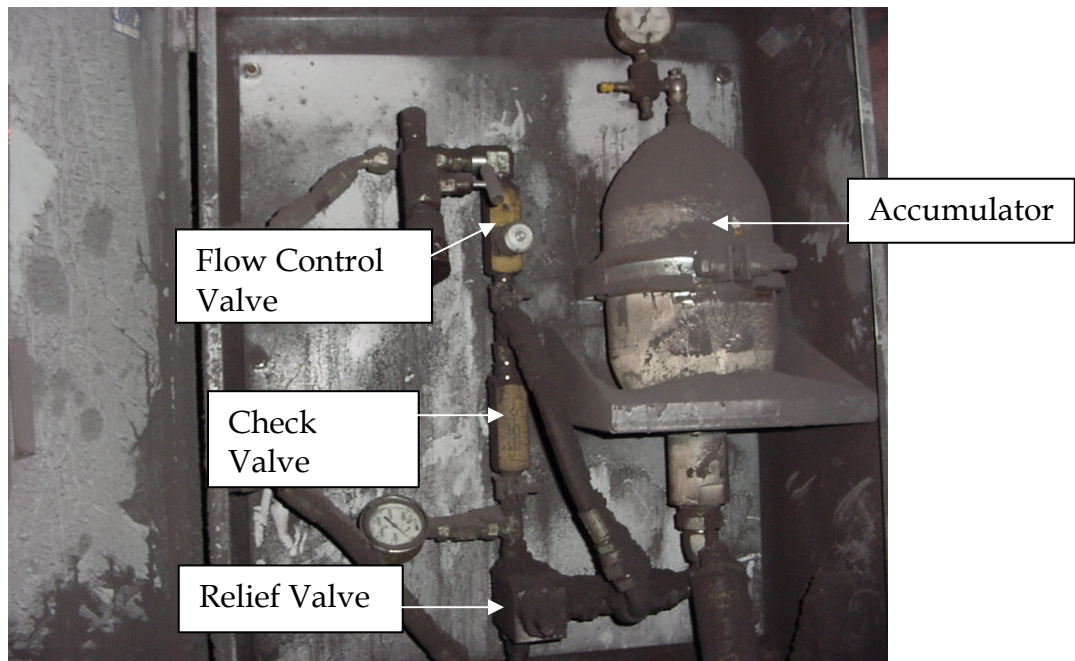
Picture #4

Reportedly, if the pallet wasn’t dumped in approximately 5 minutes, the line would have to be shut down and the cooler cleaned because the hot pellets would fuse together. Information posted inside the hydraulic motivating system cabinet, the “sure dump” - accumulator, check valve, flow control valve, relief valve, and gauges, stated the accumulator and hydraulic pressure gauges should indicate 1350 pounds per square inch gauge (psig) of pressure (see picture #4).

At the time of the investigation, the hydraulic oil pressure gauge read approximately 200 psig. The nitrogen gas pressure gauge on the accumulator read approximately 1200 psig.

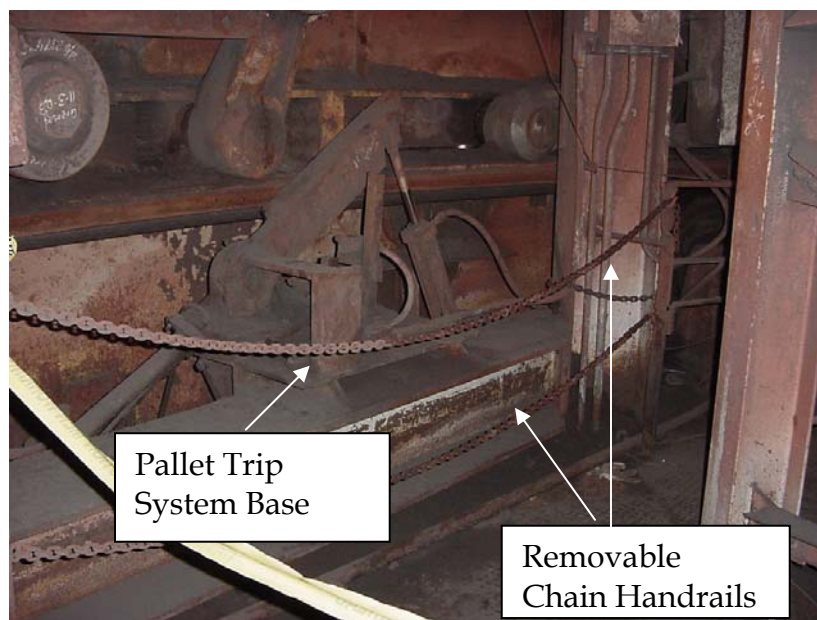
Picture #5

A walkway was provided along the inner diameter of the cooler. The outside edge of the walkway had a solid handrail in place to prevent persons from contacting the slow moving dump arms and wheels. A pull cord was positioned around the cooler circumference and near the moving wheels to stop the cooler if pulled. At the location of the stuck cooler pallet tripper arm, an approximately 98-inch wide opening existed in the solid handrailing with two removable chains provided. The upper chain was 29-½ inches from the floor and the lower chain was 14-½ inches from the floor. These chains were permanently attached at one end and slipped onto a hook positioned at the opposite end (see picture #5). When these chains were removed, access was provided to free the stuck cooler pallet dump arm.

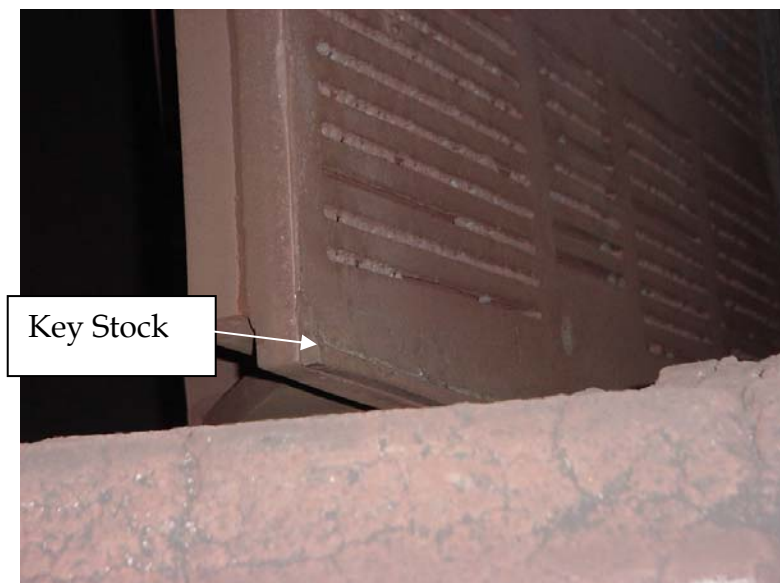
Picture #7

Unit 4 cooler was down for a maintenance outage from October 31, 2005, until the afternoon of November 5, 2005. During the outage, ½ inch X ½ inch pieces of key stock were welded at the interface of moving pallets 1, 2, and 13 through 30, and the stationary cooler walls (see picture #7). The repairs included pallet 27, involved in the incident, and were considered a normal maintenance repair for any major or minor outage. The key stock material added to the edges helped prevent spillage of pellets from the pallets. Unit 4 was re-started at 7:20 p.m. on November 5, 2005.

Miners interviewed indicated that, until the cooler reached its normal operating temperature, the pallets were more likely to stick. During the initial heat up and run in period, clearances were established by temperature and "wearing in". Consequently, pallets did become stuck after repairs due to heating and expansion of metal components.

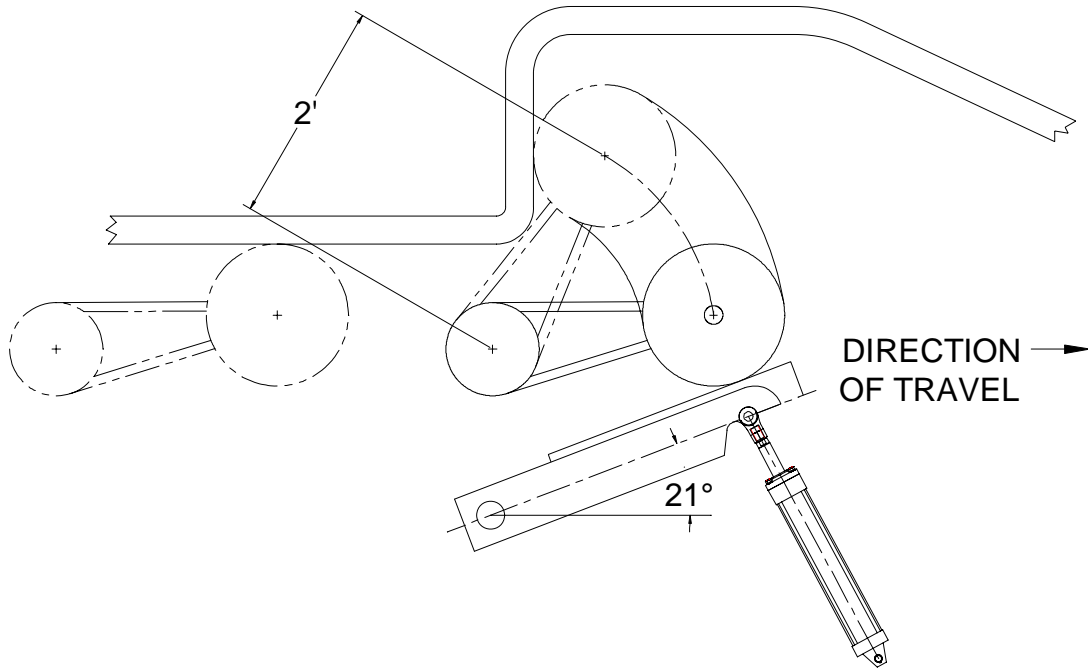
PROJECT	
		EMPIRE MINE FATALITY; NOVEMBER 6, 2005	
DATE		SUBJECT	
		SKETCH OF UNGUARDED WHEEL TRAVEL AREA	
12/5/2005		DWG NO.	REV
91938-001		0	
DWG SIZE: B		SCALE: NTS	SHEET 1 OF 1

The distance between the cooler frame and the trip wheel was approximately 25 inches when in a stuck pallet position. The open area through which the trip wheel could travel when freed was approximately 2 square feet and was not

A fatal accident occurred at this mine on November 6, 2005, when an assistant plant operator was struck by a cooler dump arm. The victim and his co-worker were attempting to free a stuck cooler pallet when the pallet broke free, the dump arm moved suddenly and pinned the victim against the cooler framework. A guard was not provided at the cooler pallet dump arm release area to protect persons against the sudden movement of the cooler pallet dump arm upon release from the stuck position.

This citation was terminated on January 30, 2006. A guard was installed at unit 4 to prevent access to the cooler pallet dump arm. New policies and procedures were implemented to ensure that persons are protected from movement of the dump arm. Retraining was provided to miners working with the system.
